FACILITY STATUS CHANGE FORM

Date Submitted: August 1, 2013 Originator: Chris Strand Phone: 554-2720	Area: 300 Area Facility ID: 328, 328A, and 328BA Action Memorandum: Action Memorandum #3	Control #: D4-300-015-1
---	--	-----------------------------------

Attachment 1: Facility Information

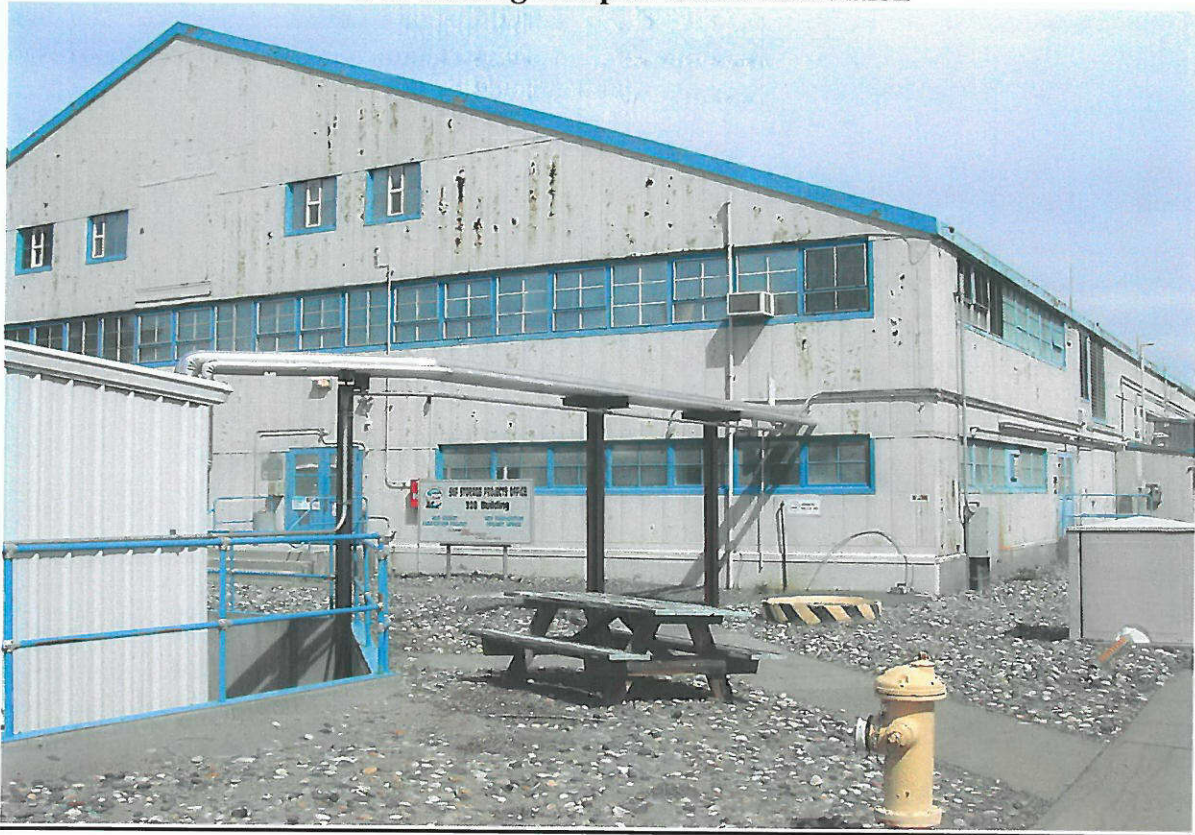
328 Building Complex before Demolition

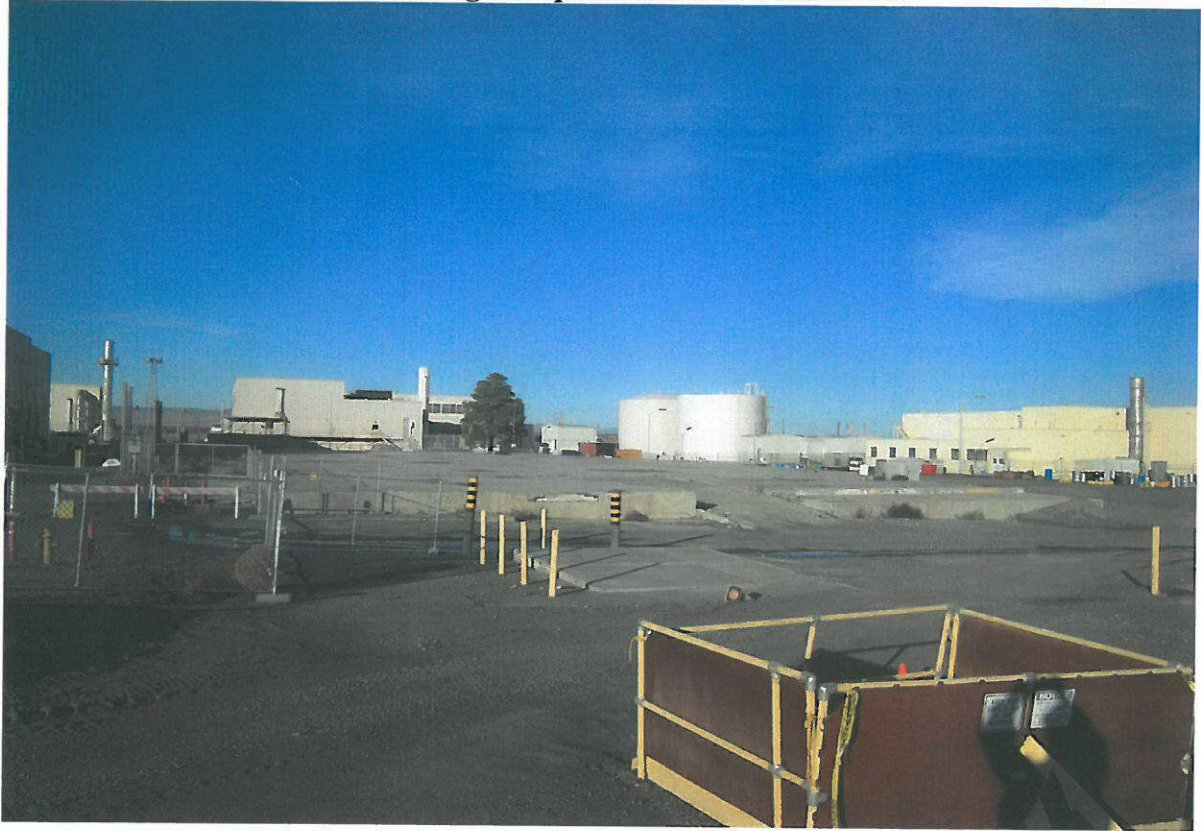
The 328, 328A, and 328BA slabs and below-grade foundations remain in place and are within the 300 Area posted URMA. No Industrial Hygiene postings remain.

328 Building Complex Site after Demolition
